**DIRECTORATE-GENERAL OF MINES SAFETY**

DGMS (Tech)(SOMA) Circular No.1 of 2001

**Sub: Recommendations of Gaslitand Court of Inquiry**

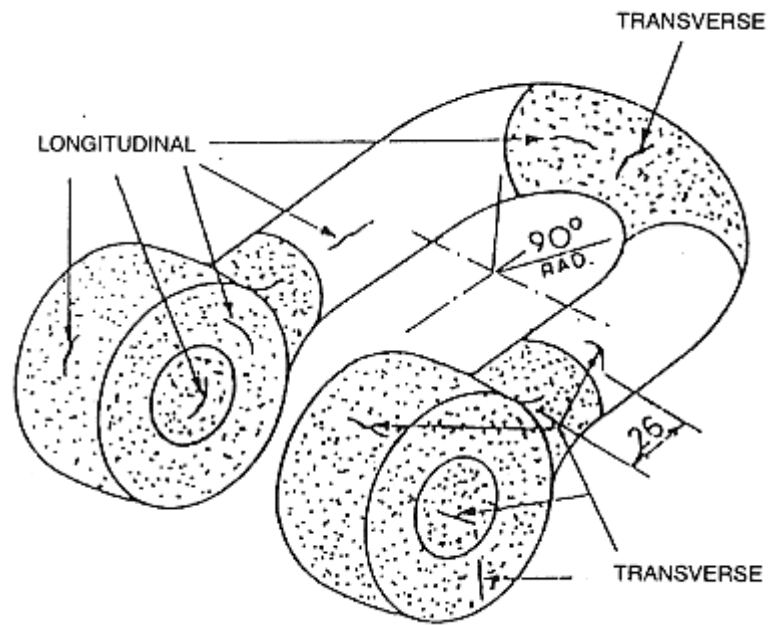
ALL DIMENSIONS IN MILLIMETRES

PART	TYPE OF IMPERFECTION	PERMISSIBLE IMPERFECTIONS
SHACKLE BODY	SHADED AREAS TRANSVERSE	NONE
	LONGITUDINAL	NONE > 10mm (3/8")
SHACKLE BODY	UNSHADED AREAS TRANSVERSE	NONE
	LONGITUDINAL	NONE > 32mm (1 1/4")
