**Subject: Fatal Accident on RapidKL Depot Expansion Project adjacent to SCOMI  
Bombardier compound (lesson learnt)**

**When** : 17<sup>th</sup> May 2010  
**Time** : 11:00am  
**Venue** : RapidKL Subang Depot compound adjacent to Scomi site office(KLJ Project)

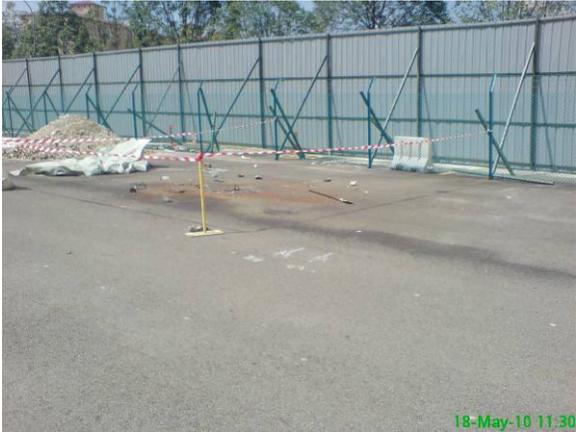
Once the 12 inch disc was fitted onto the grinder (not sure how it was done, still being investigated) the worker started cutting the manhole steel cover which approximately has a thickness of 0.5 to 1cm. He managed to cut through to a length 3/4 of the cover's diameter, all of a sudden most probably, due to long duration and extreme force applied or the quality and durability of the disc that was being used cracked and struck his face and threw him to the ground.

A portion of the broken disc was lodged on his right temple till his right chin killing him 15 minutes after its occurrence.

Accident

This above fatal accident could be avoided if the work had been closely supervised, the right tool used, proper PPE, had the hazard been identified, assessed and the control measures disseminated to all the employees before work is commenced at site.

I will come up with some guidelines on usage power tools, will distribute it to all concerned accordingly ASAP. In the meantime please discuss or retrain your staff during the morning brief or tool box talk, especially those work that requires usage of power tools to prevent any untoward incident.

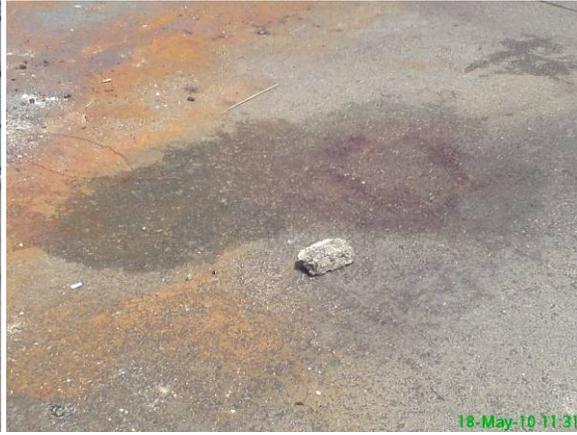
Blood

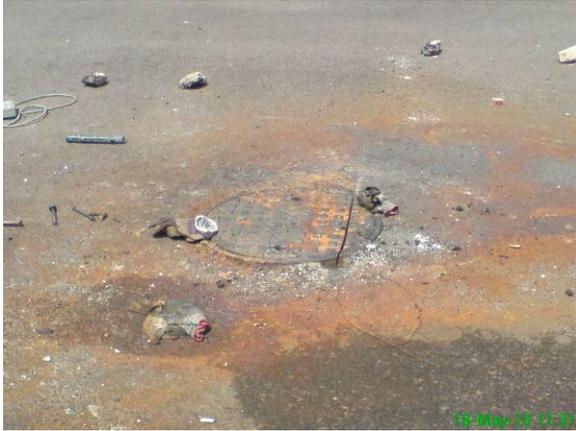
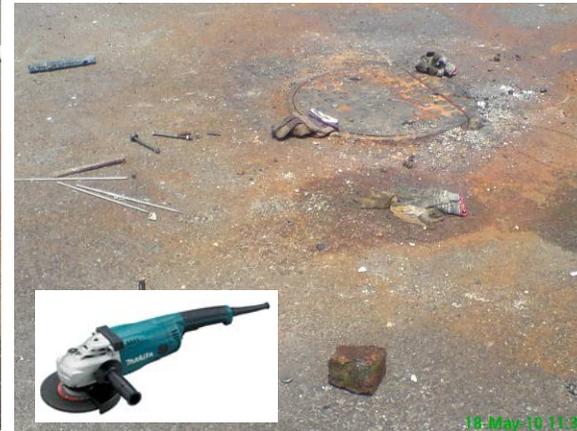
The worker was trying to open a man hole steel cover that is located at the accident site, As they did not have the right tool to open the steel cover, they tried opening it with other tools but failed to open it and also damaged the slot used to insert the actual tool to open it, the worker finally decided to cut the manhole steel cover using a hand grinder.

They initially tried cutting it with the normal 6 inch disc but it did not work, so finally the worker decided to try and use a 12 inch disc (still under investigation who actually gave this instruction?) although the report states the supervisor was present at site. As the 12 inch disc could not fit into the hand grinder as the protective guard only allows the right size disc to be fitted on it, he decided to remove the guard to allow a 12 inch disc to be fitted onto the hand grinder.

Victim cutting the manhole using 7" Angel grinder (disc size maximum 7 inch)
